# NSPIRE's Inspection Killers

Exploring common pitfalls and challenges in NSPIRE inspections, and how to overcome them for better outcomes.

# Common Deficiencies in NSPIRE Inspections that cause failures

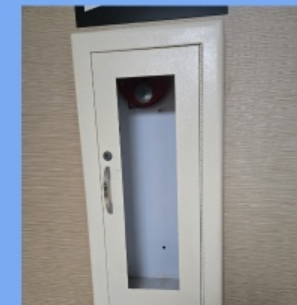
Missing Fire Extinguisher

Missing service tags are identified as Life Threatening, leading to dramatic point loss and potential inspection failures.

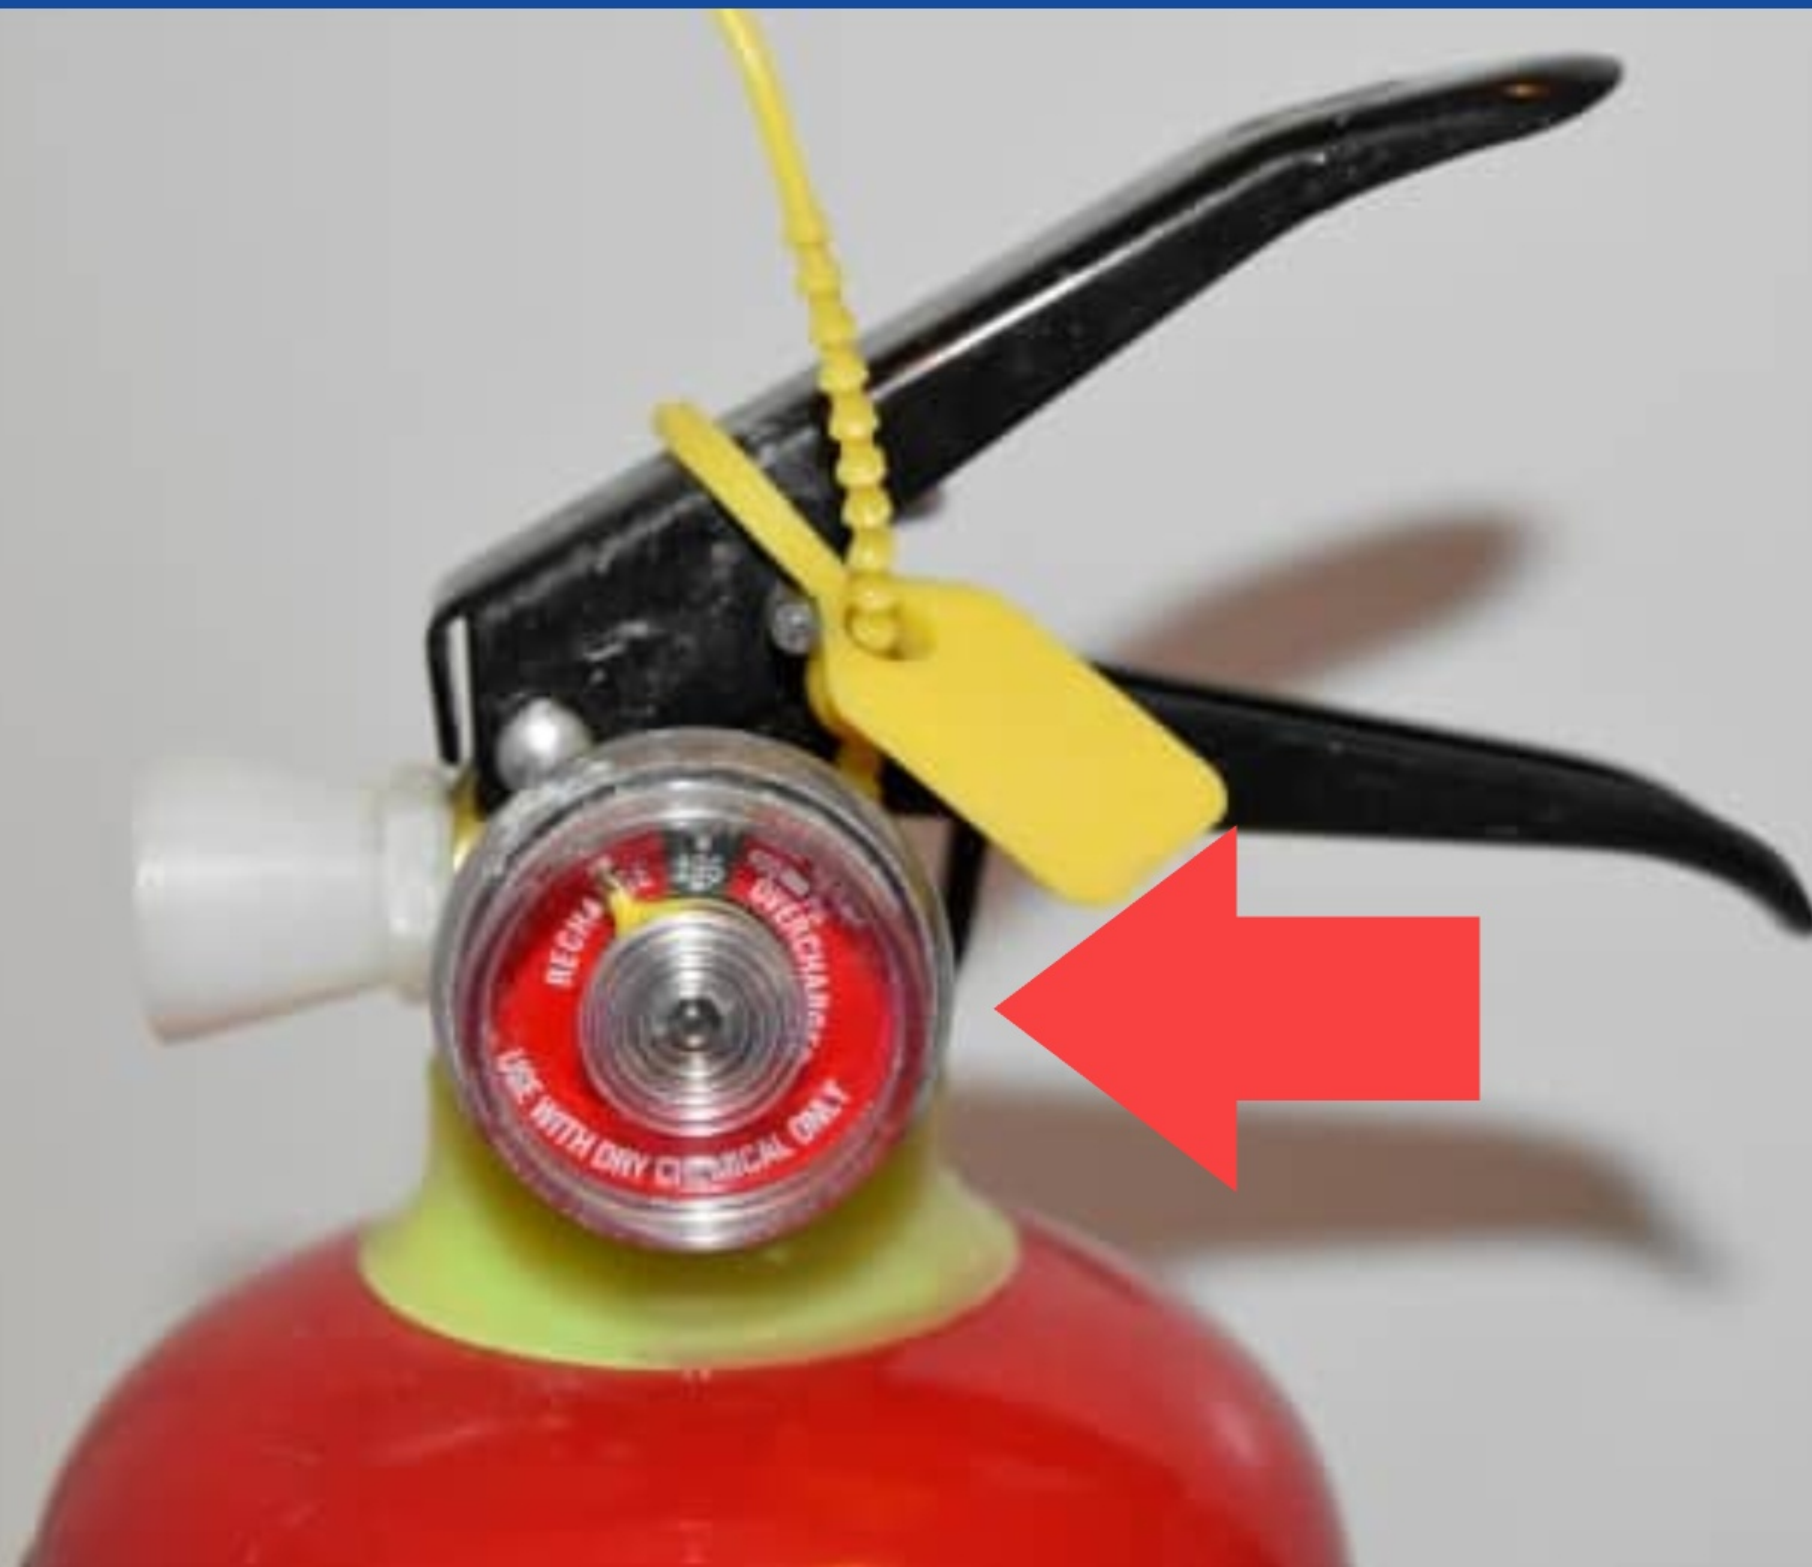
# Undercharged

Fire extinguishers with missing, illegible, or expired service tags during inspections tend to be systemic, or found multiple times on a site.

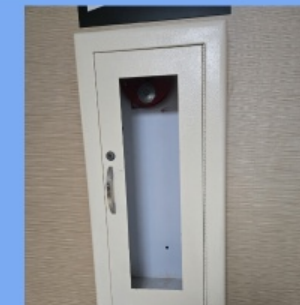
Missing Fire Extinguisher

Missing service tags are identified as Life Threatening, leading to dramatic point loss and potential inspection failures.

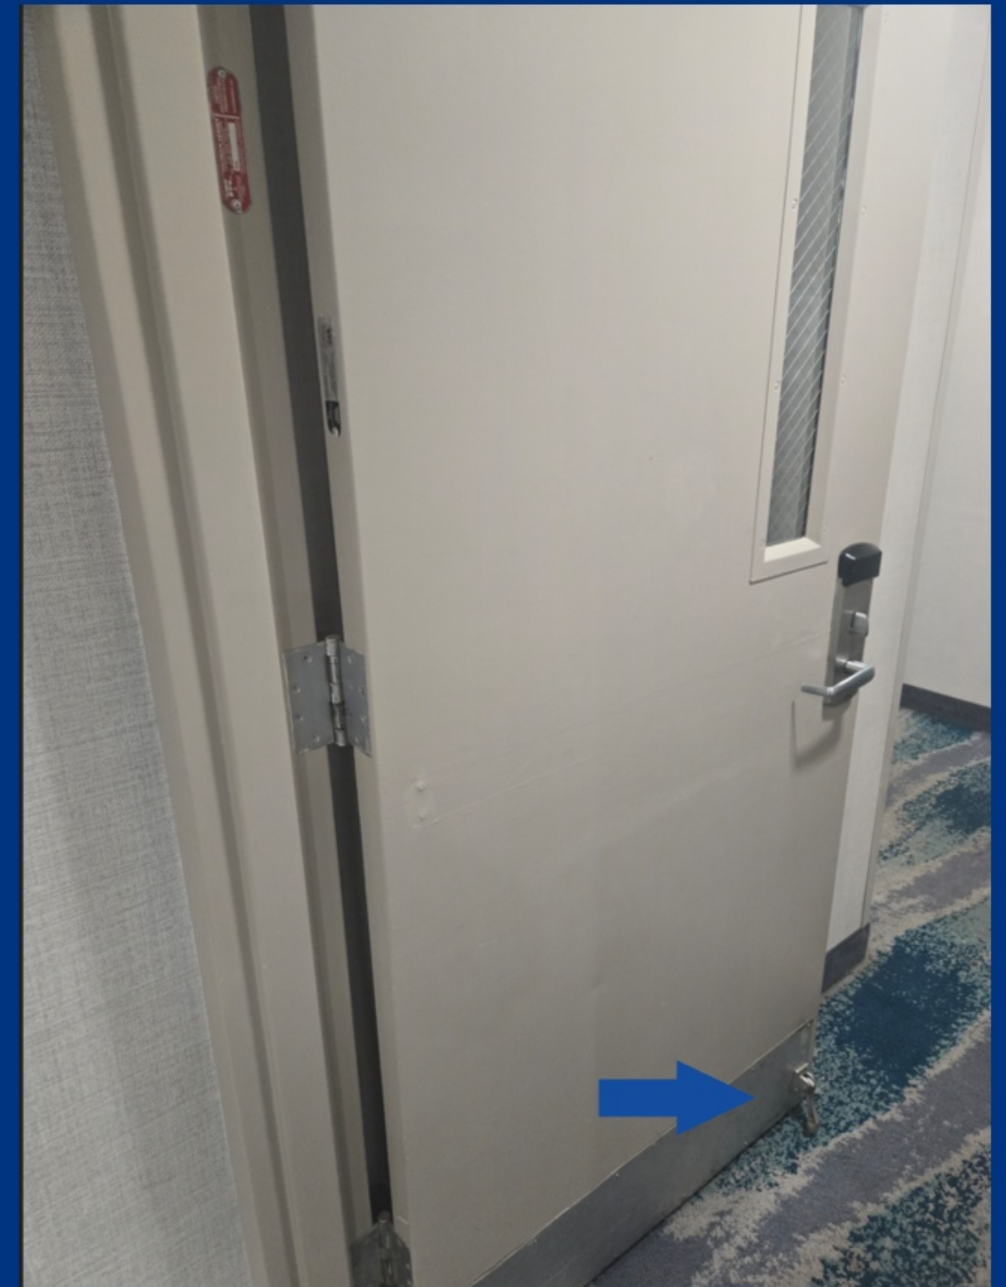
# Doors

# Fire Labeled Doors

Deficiencies are often systemic and will be identified multiple times at a site. Point loss occurs when fire doors are obstructed, compromised by holes or have malfunctioning closers, which are critical for maintaining safety during a fire.

Acoustic and fire-rated doors are required at a fire door opening in a fire-rated wall or partition.

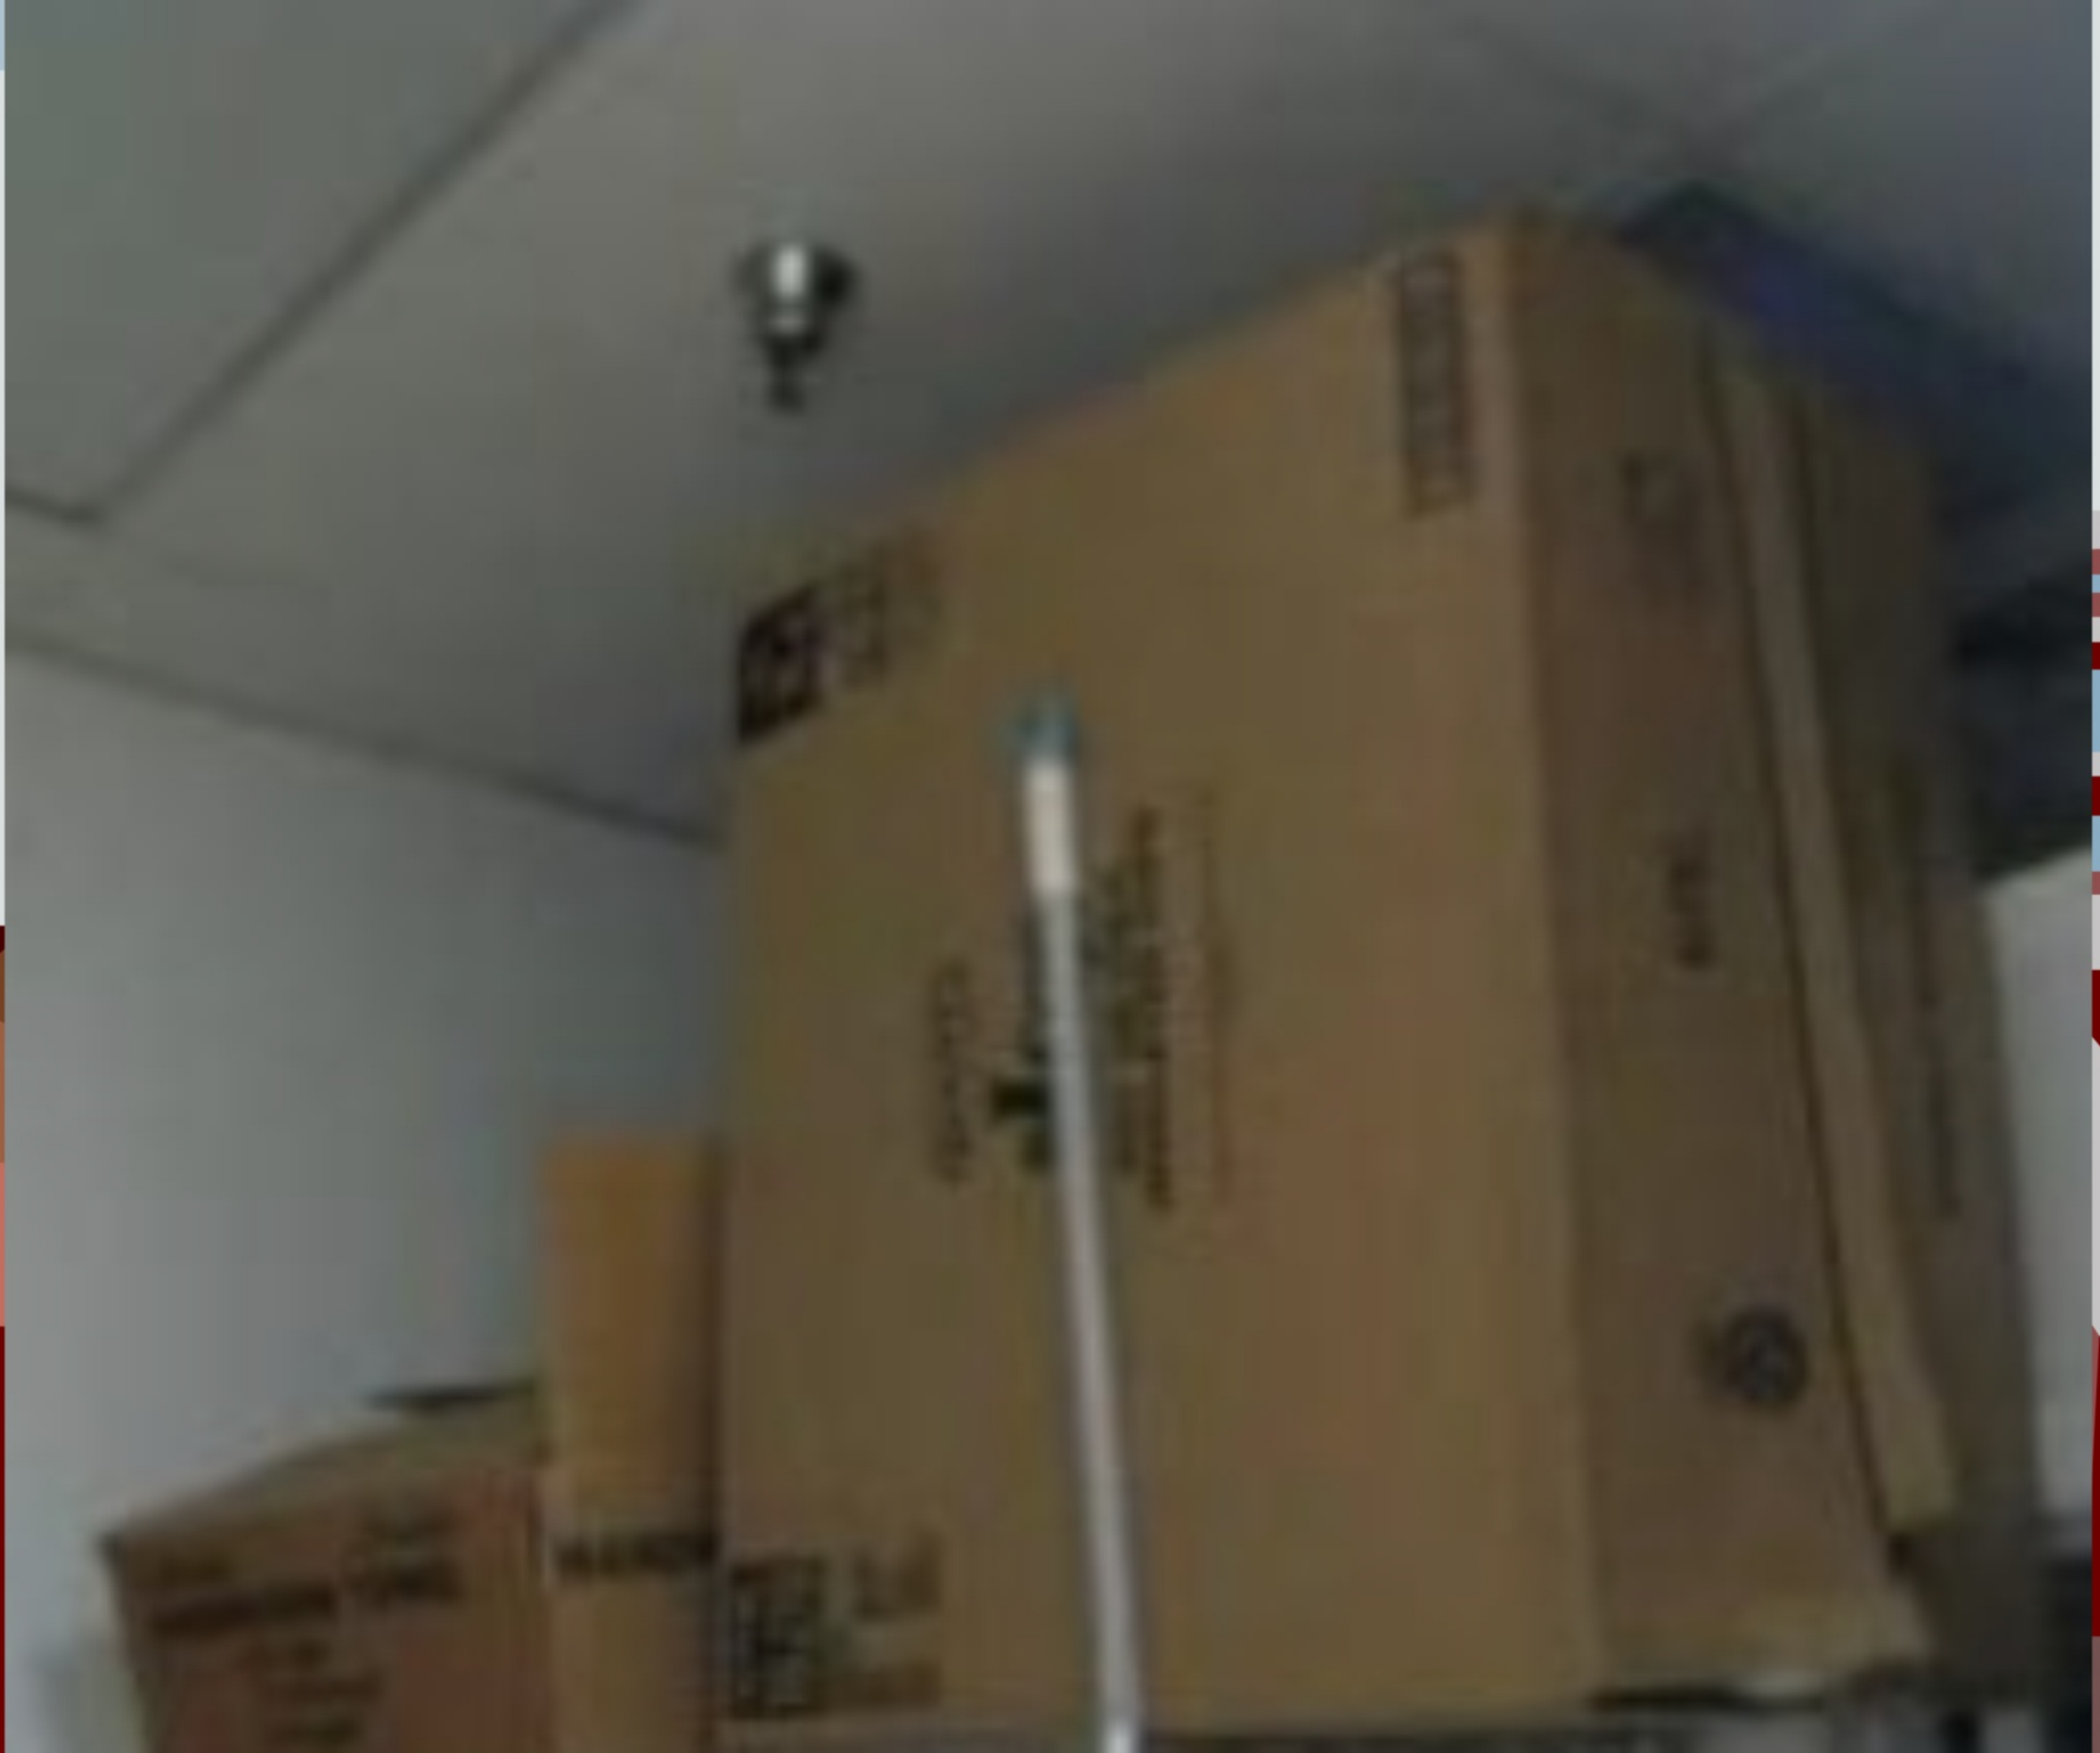
Obstructions in fire sprinklers are equally classified as Life Threatening, resulting in the same point loss of 2.4 in units and 2.18 inside a 100 unit property with 25 sampled units. These obstructions can hinder the effectiveness of fire suppression systems, emphasizing the critical nature of ensuring clear access to all sprinkler heads.

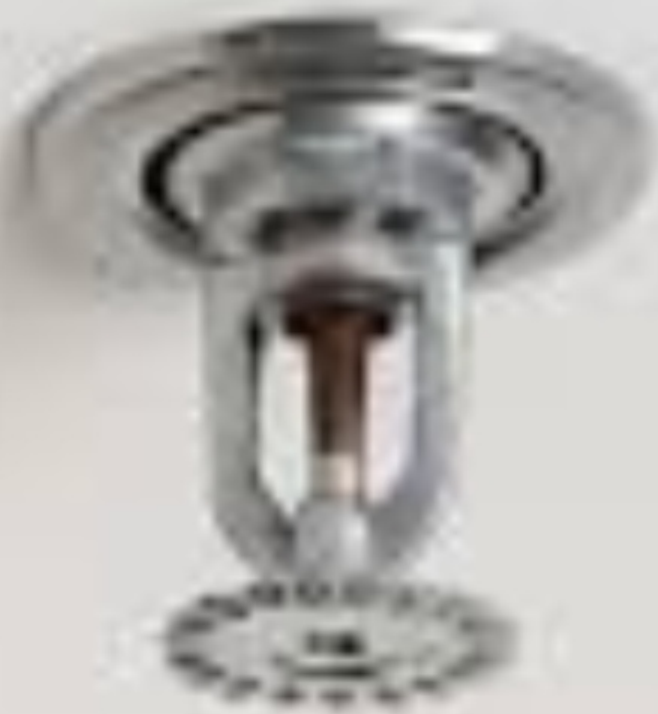
## Fire Sprinkler Obstruction

**18 IN.**  
**(0,46 m)**

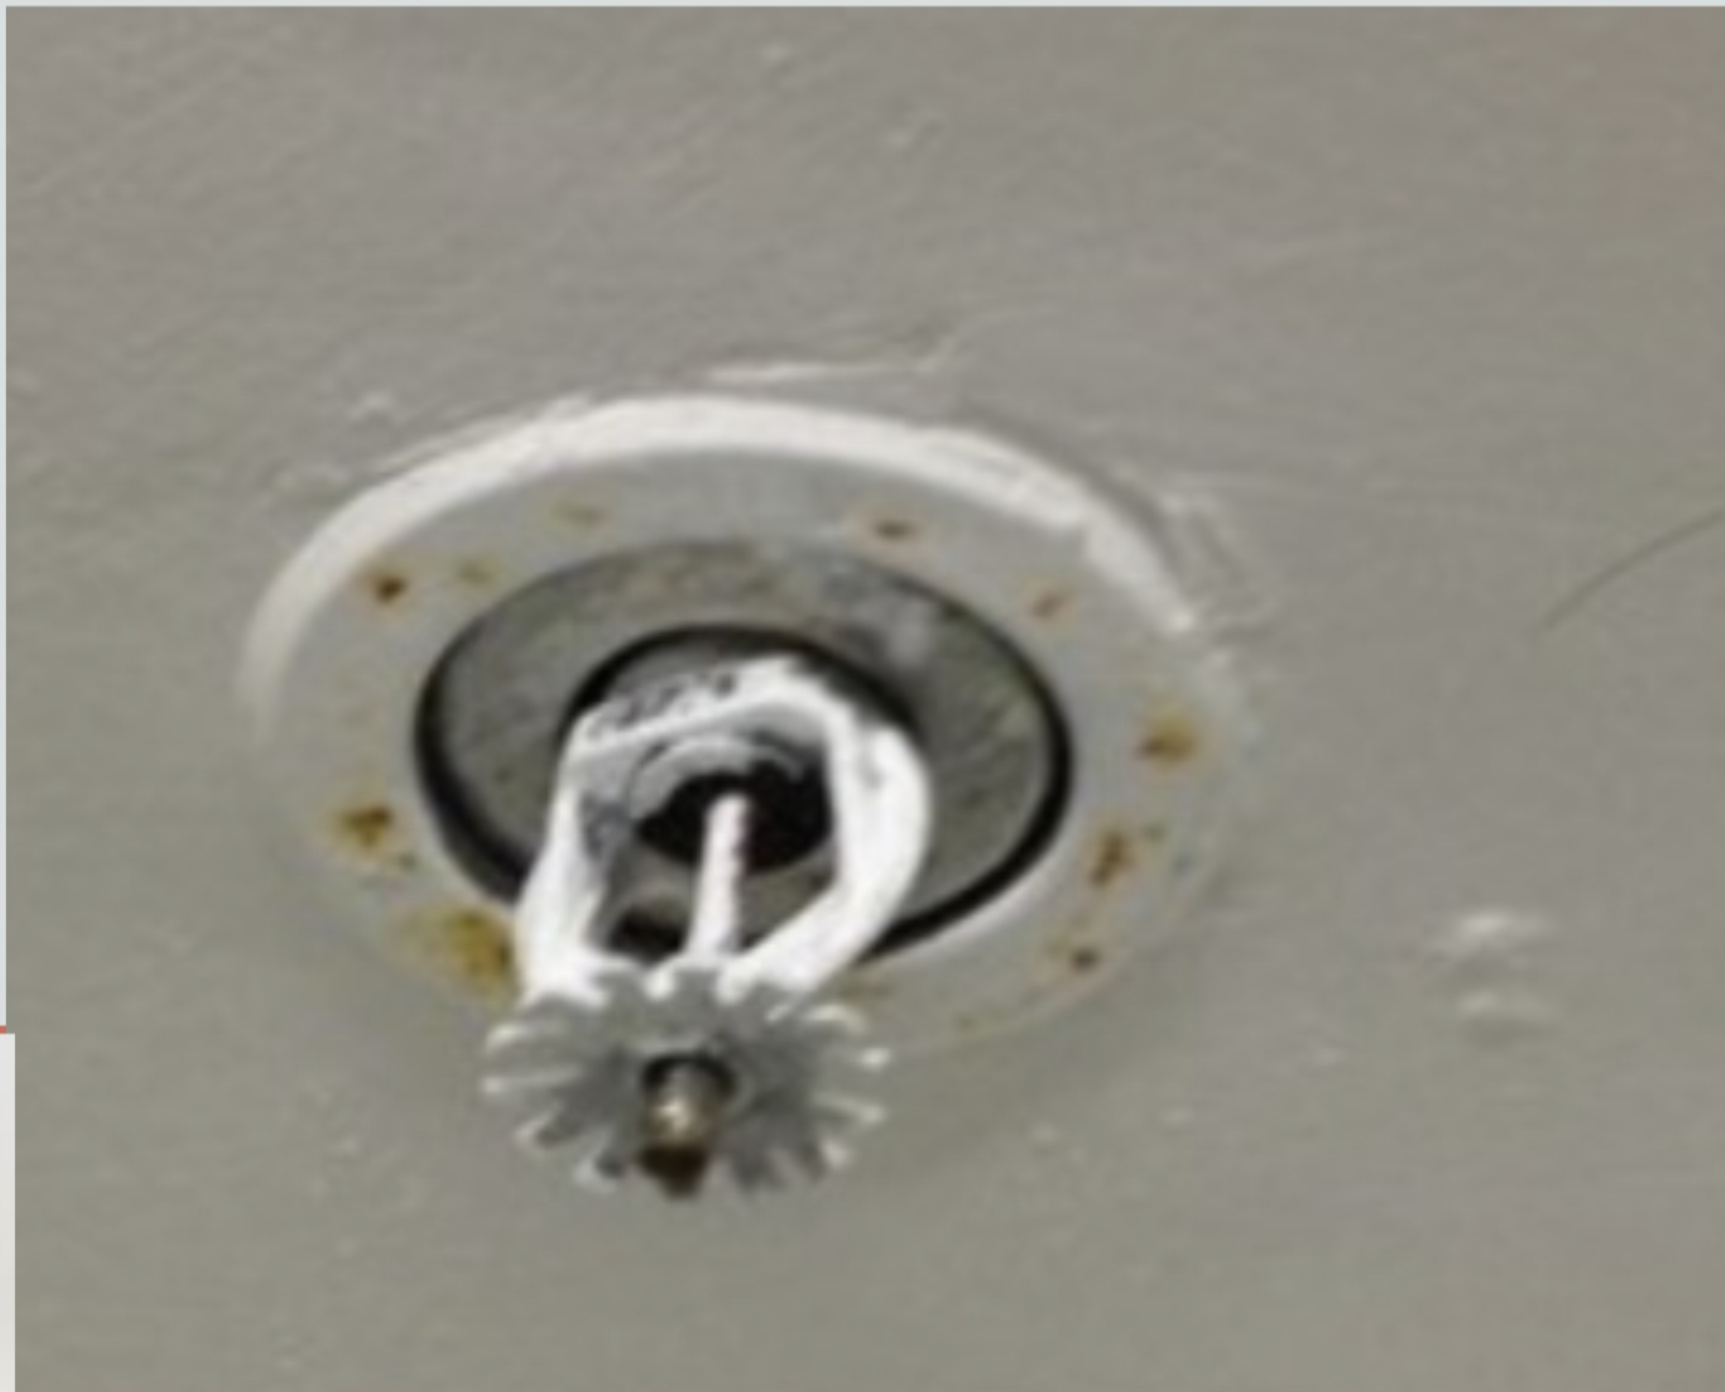
## Fire Sprinkler Overspray

Fire sprinklers with overspray are Life Threatening deficiencies, often leading to significant point loss during inspections. On a 100 unit property with 25 sampled units, the point loss averages 2.4 in units and 2.18 inside. This common issue can frequently be found at various sites, underscoring the need for regular maintenance and checks.

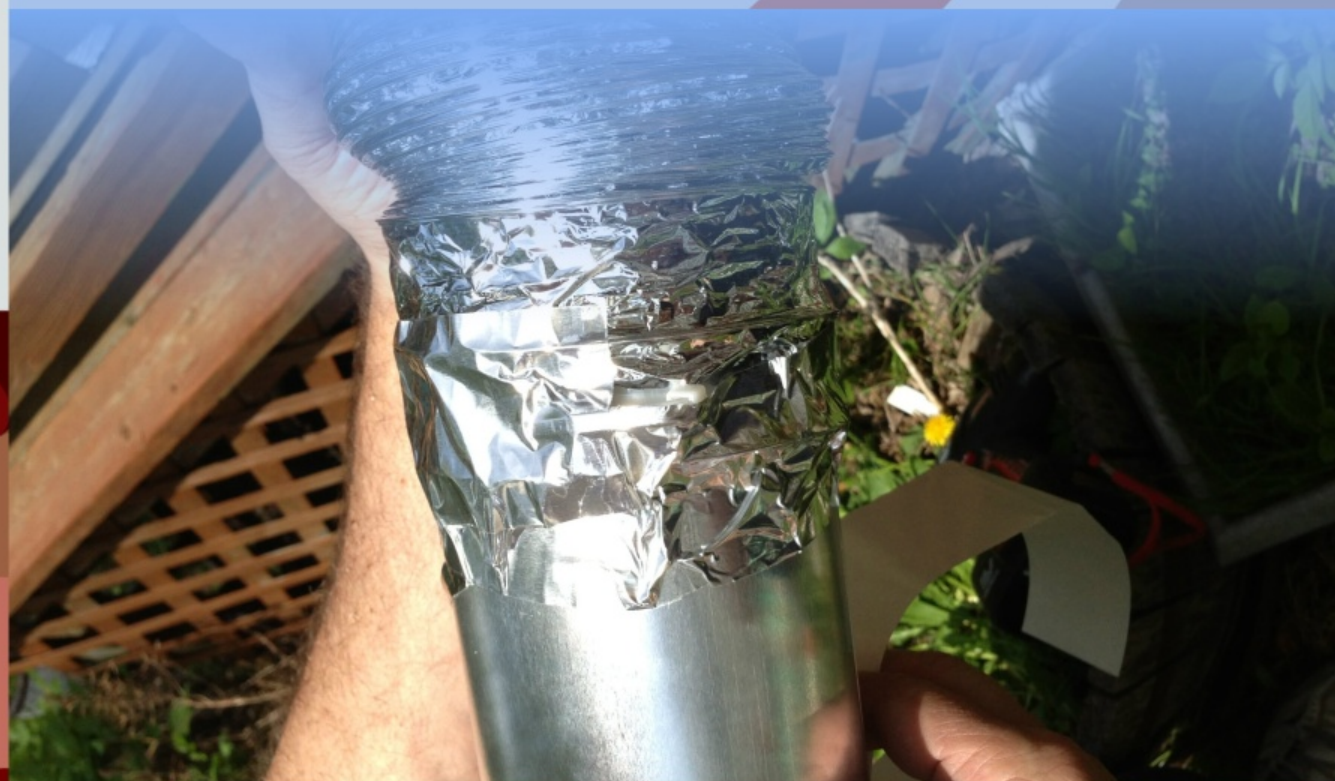
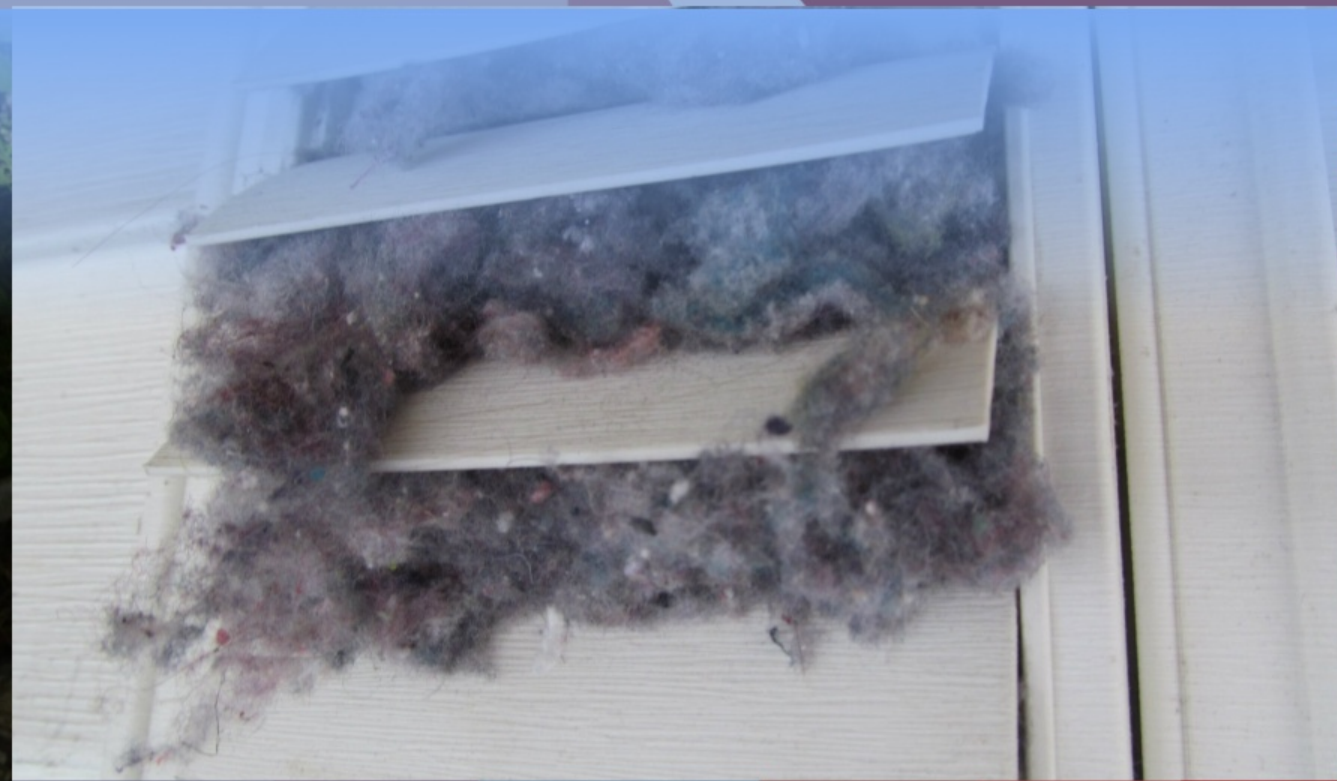
Inappropriate materials or disconnections in dryer vent transitions pose significant Life Threatening risks. On a 100 unit property with 25 sampled units, this can result in a point loss of 2.4. These issues frequently arise when tenants attempt to install their own dryers, highlighting the importance of proper installation and materials.

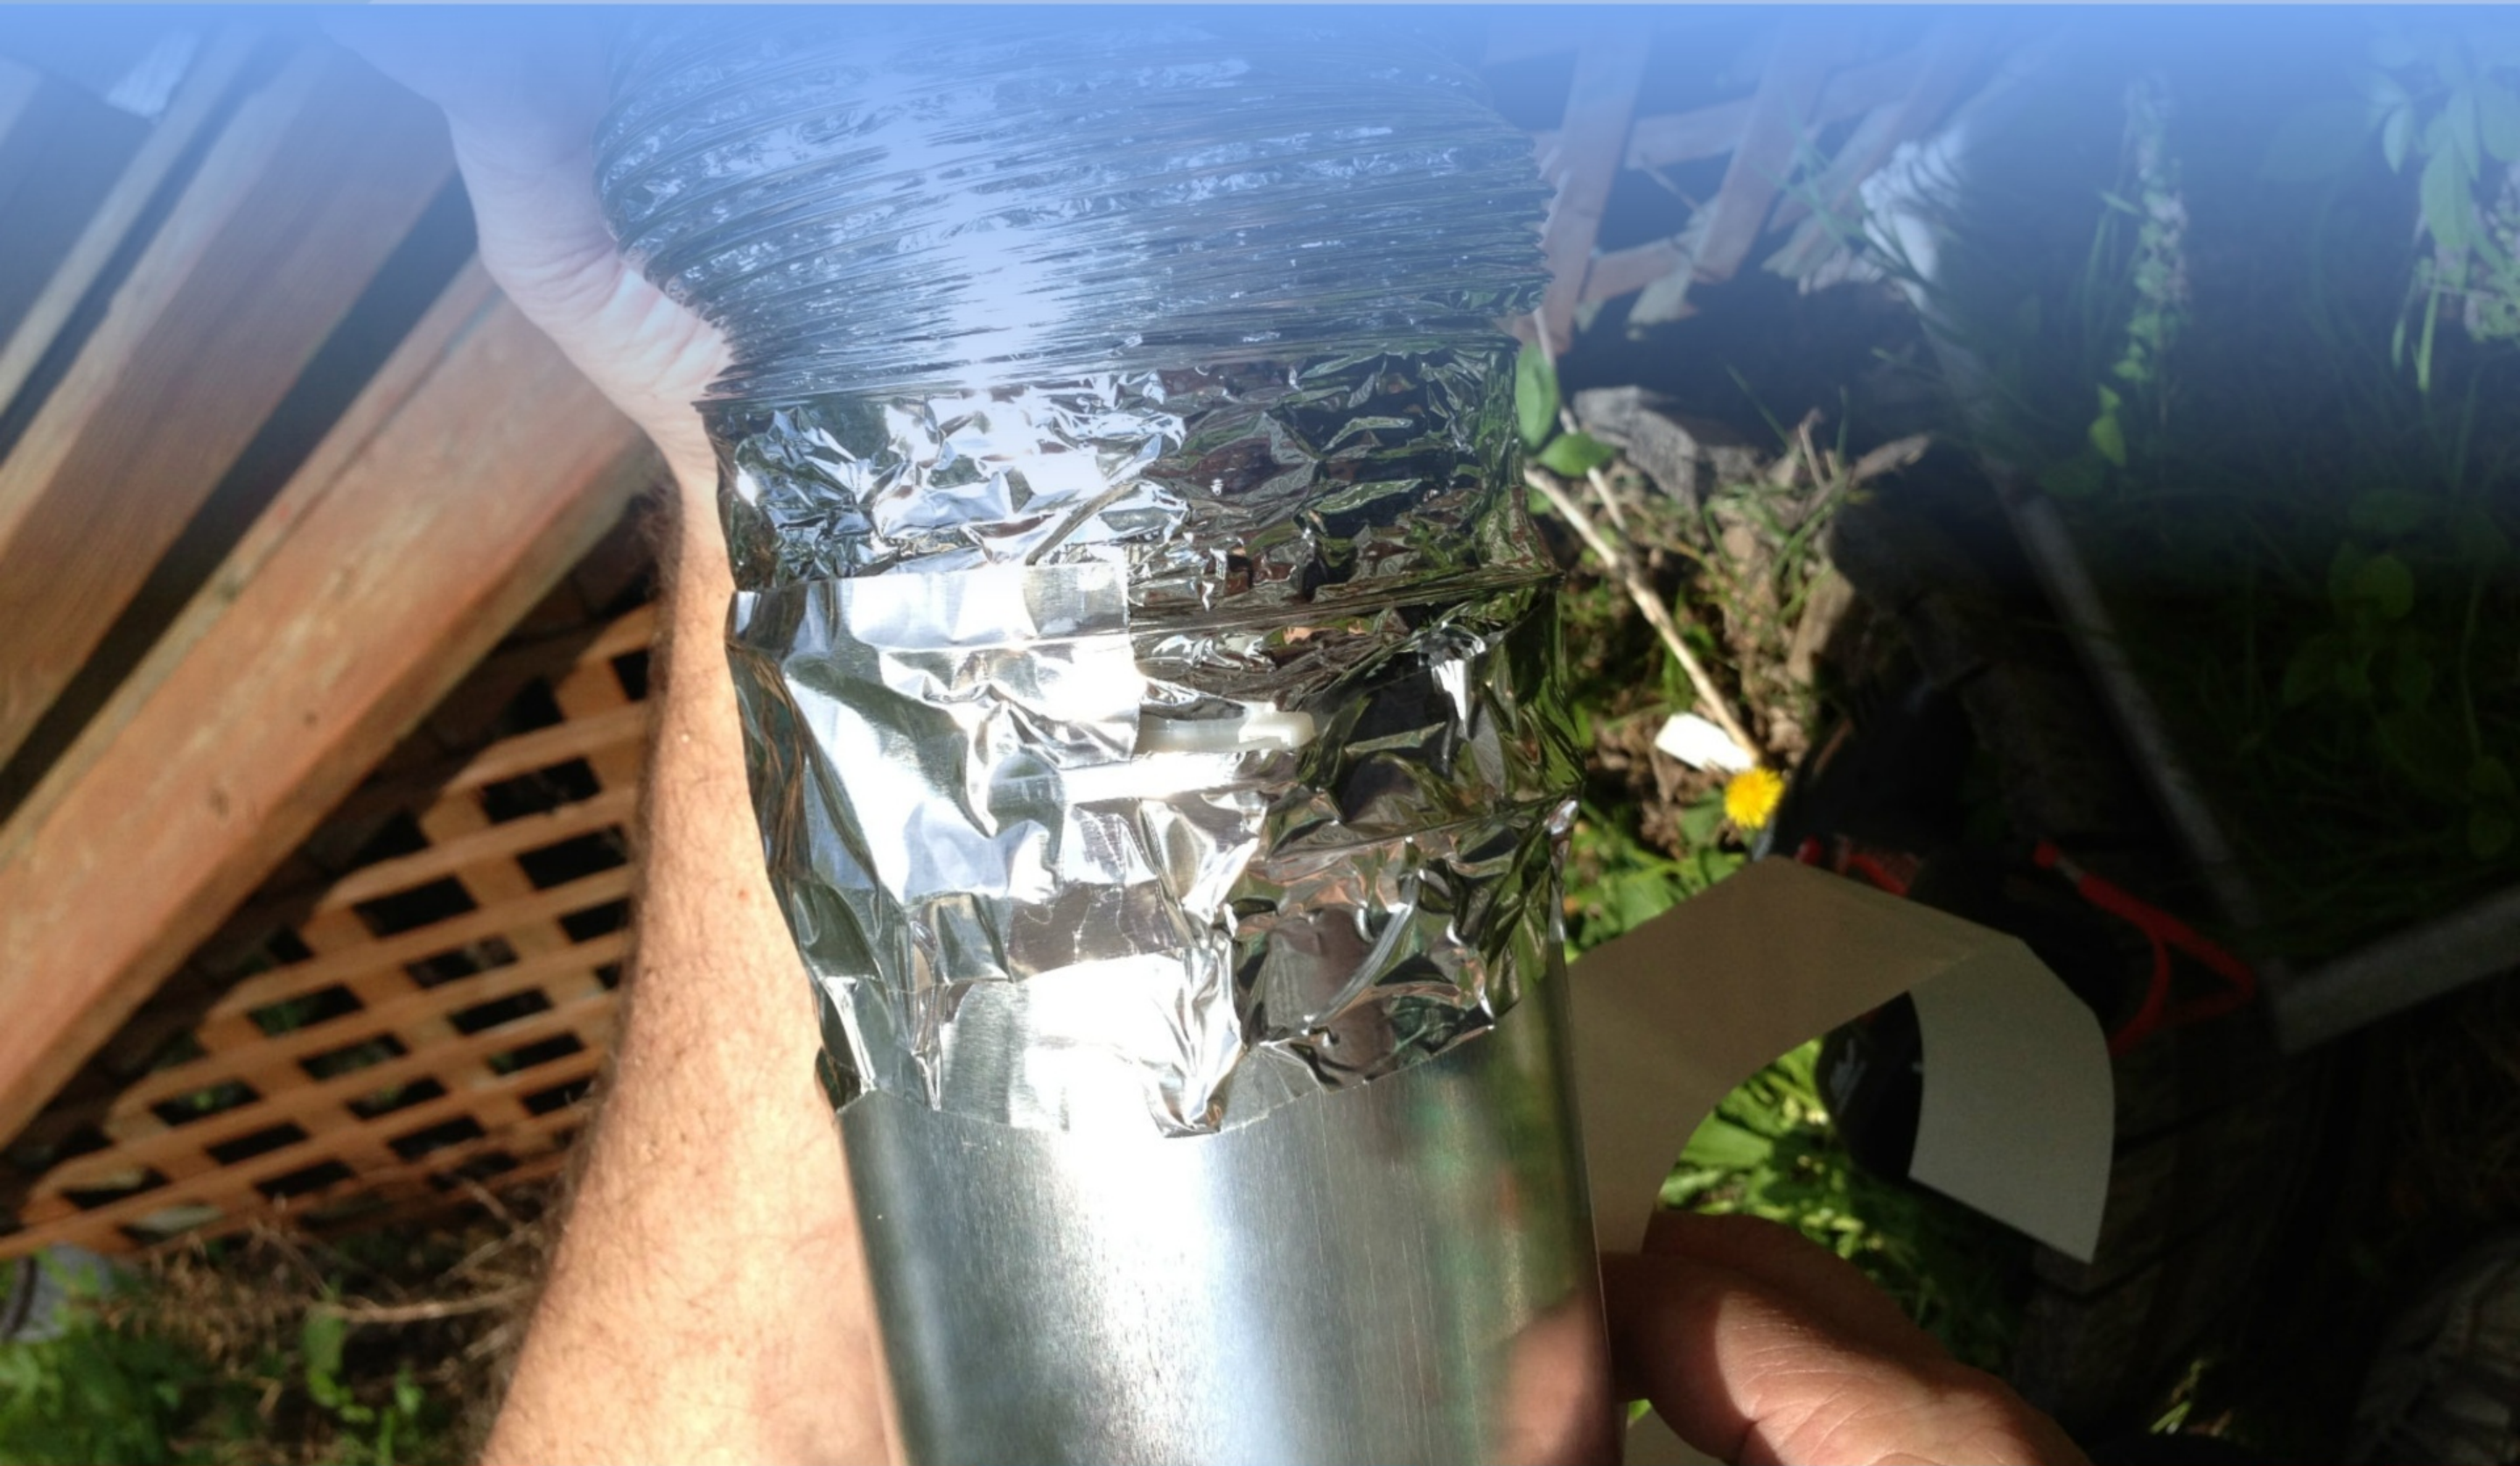
Def# 5. DRYER TRANSITION DUCT IS CONSTRUCTED OF UNSUITABLE MATERIAL

Def# 6. GAS DRYER EXHAUST VENTILATION SYSTEM HAS RESTRICTED AIRFLOW

All dryer related deficiencies including transition ducts, restricted airflow, unsuitable materials are all Life Threatening, with a unit point loss of 2.4 per deficiency in a unit with a sample of 25 units.

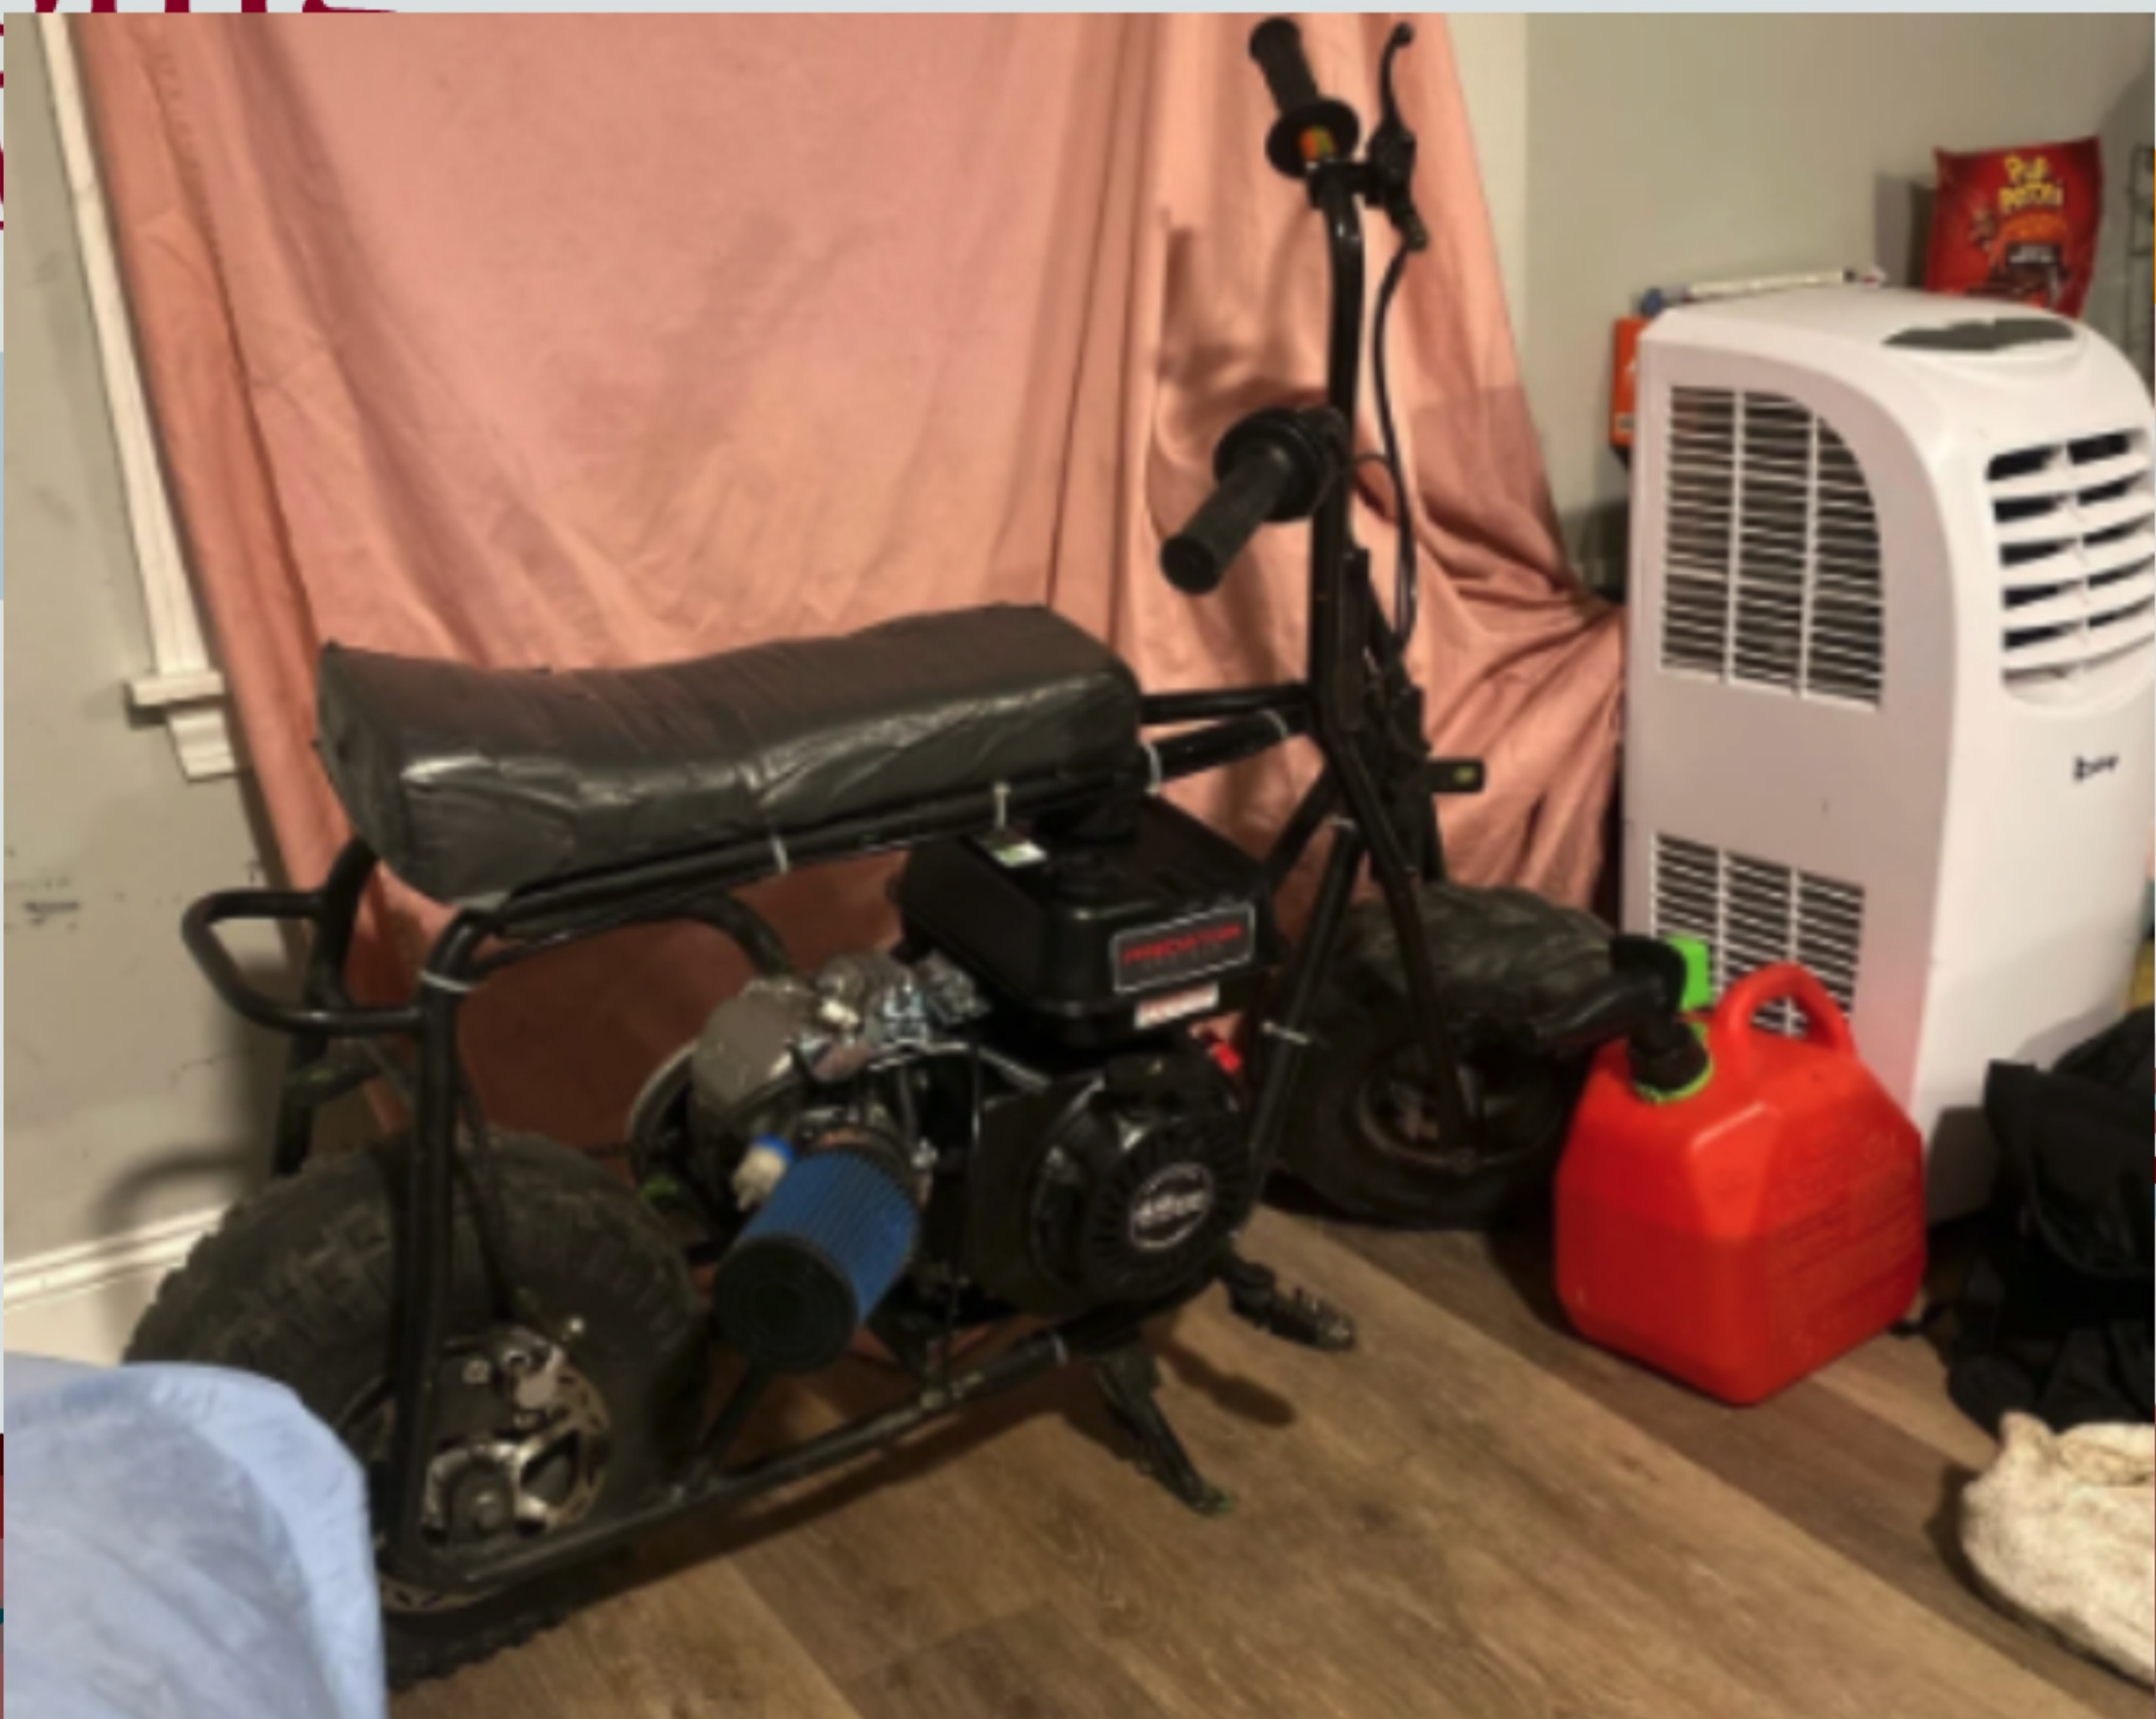
# Hazardous Flammable Storage

Flammable materials stored in HVAC closets pose significant safety risks, classified as Life Threatening deficiencies. These hazards can lead to severe consequences including fire outbreaks, resulting in a point loss of 2.4 on a 100-unit property based on 25 sampled units.

Flammable materials stored in HVAC closets pose significant safety risks, classified as Life Threatening deficiencies. These hazards can lead to severe consequences including fire outbreaks, resulting in a point loss of 2.4 on a 100-unit property based on 25 sampled units.

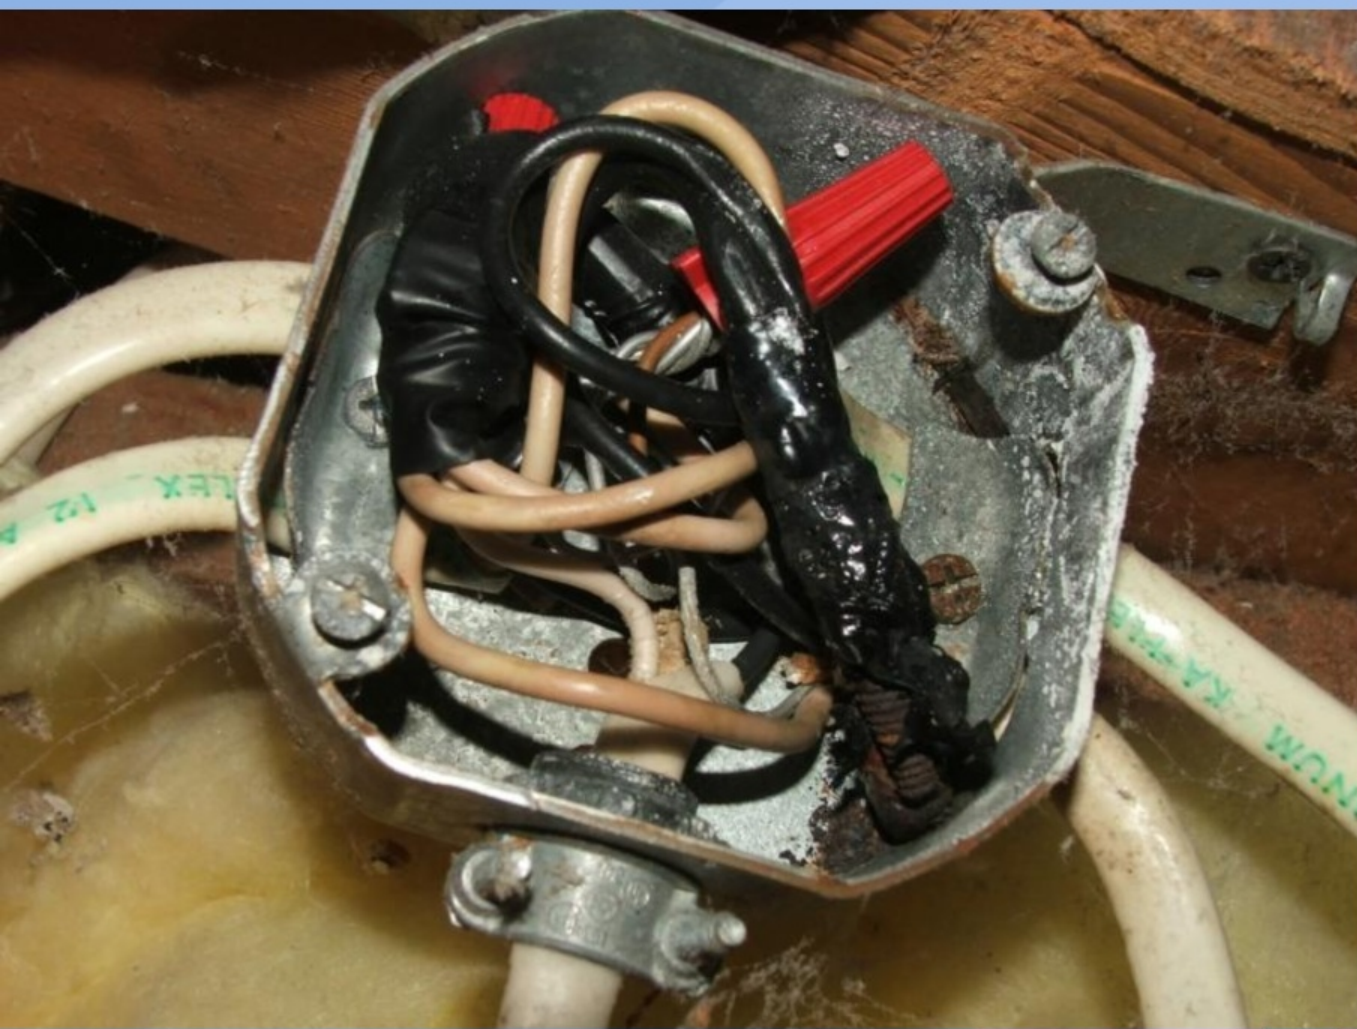
## Romex Connectors

Exposed conductors are frequently found on garbage disposers with loose romex connectors or HVAC whips from service disconnects. This condition can lead to significant safety hazards and compliance issues.

Exposed conductors are frequently found on garbage disposers with loose romex connectors or HVAC where from service disconnects. This condition can lead to significant safety hazards and compliance issues.
