# NSPIRE's Inspection Killers

Exploring common pitfalls and challenges in NSPIRE inspections, and how to overcome them for better outcomes.

# Common Deficiencies in NSPIRE Inspections that cause failures

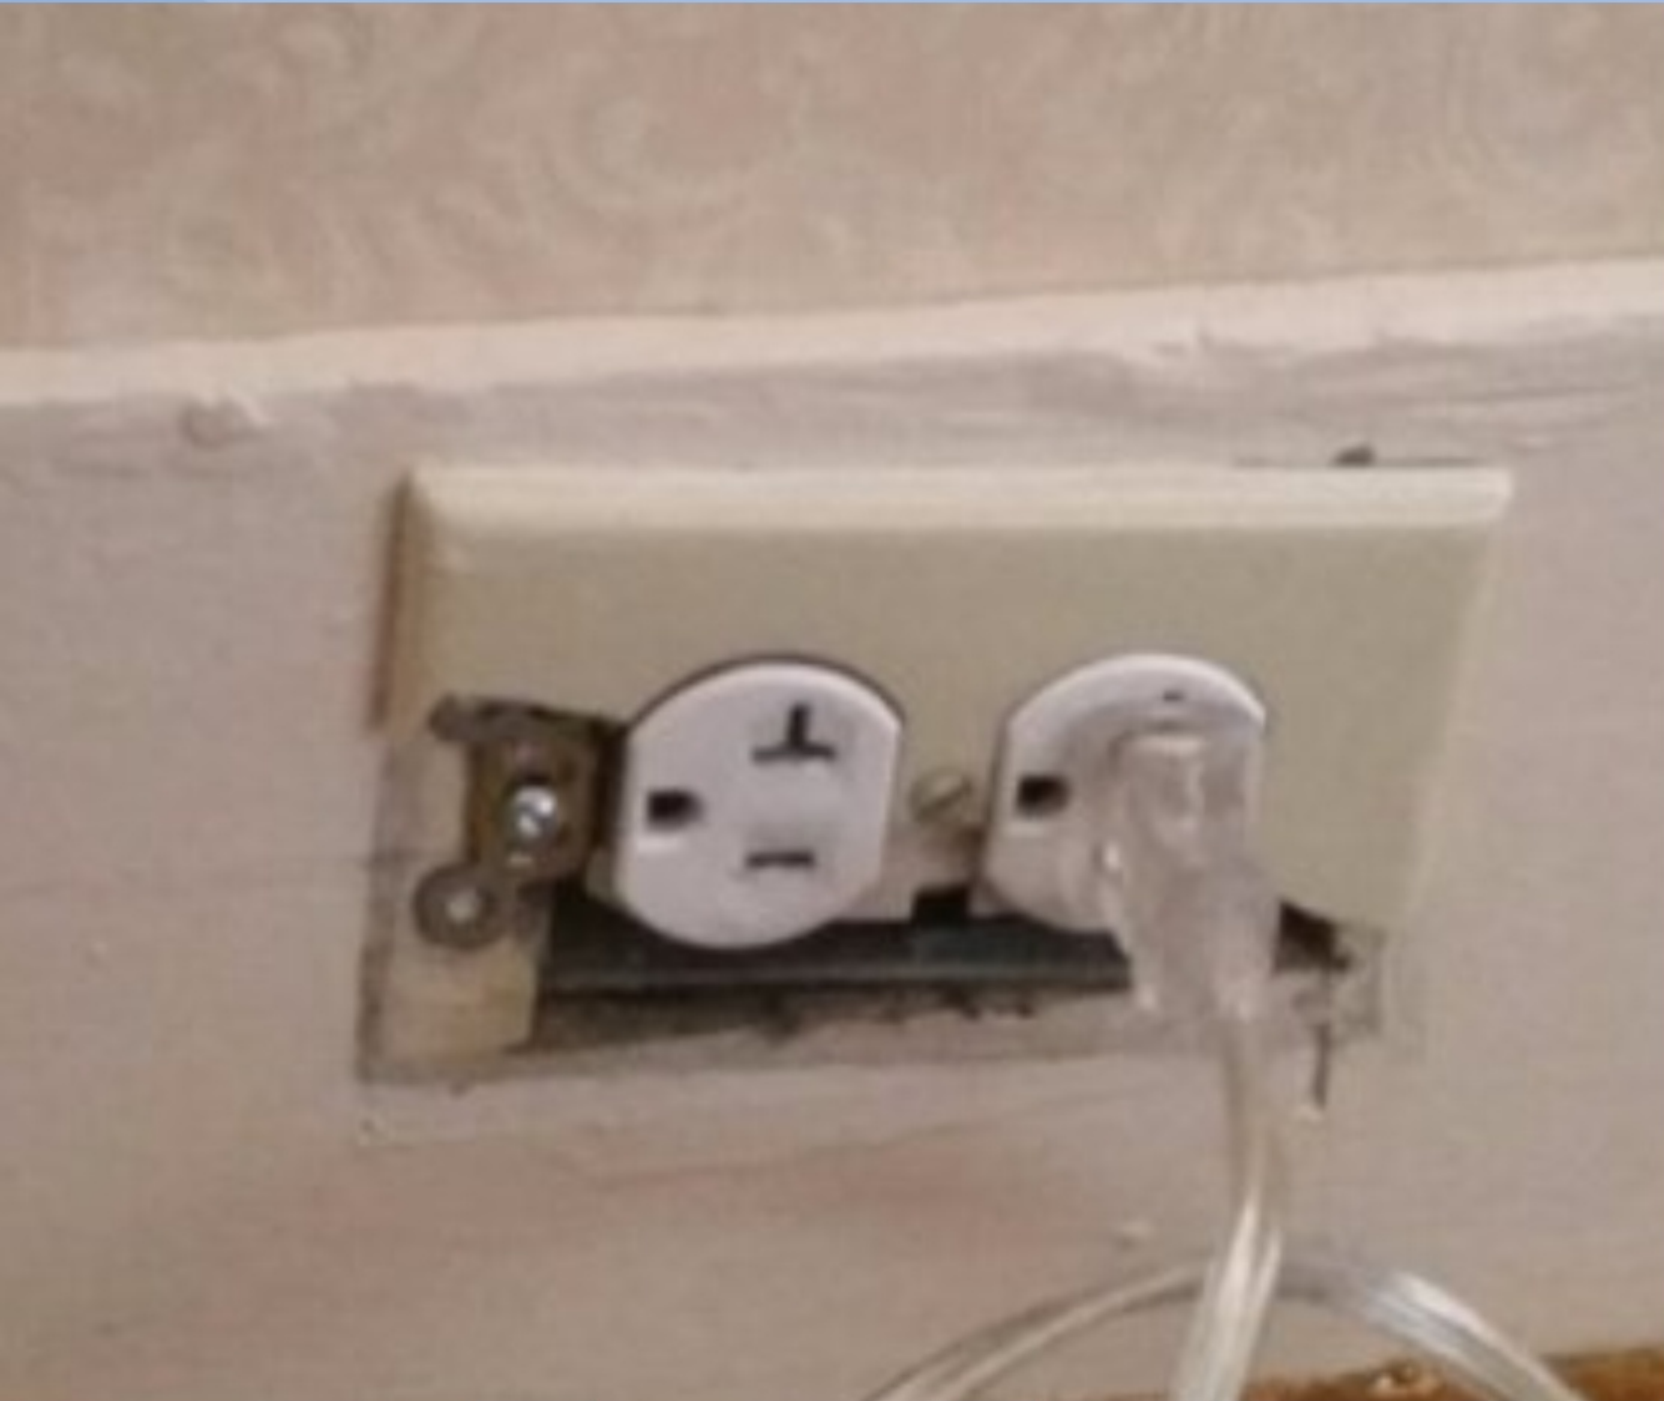
## Broken Outlet Covers

Broken Outlet Covers are citable when they expose a conductor

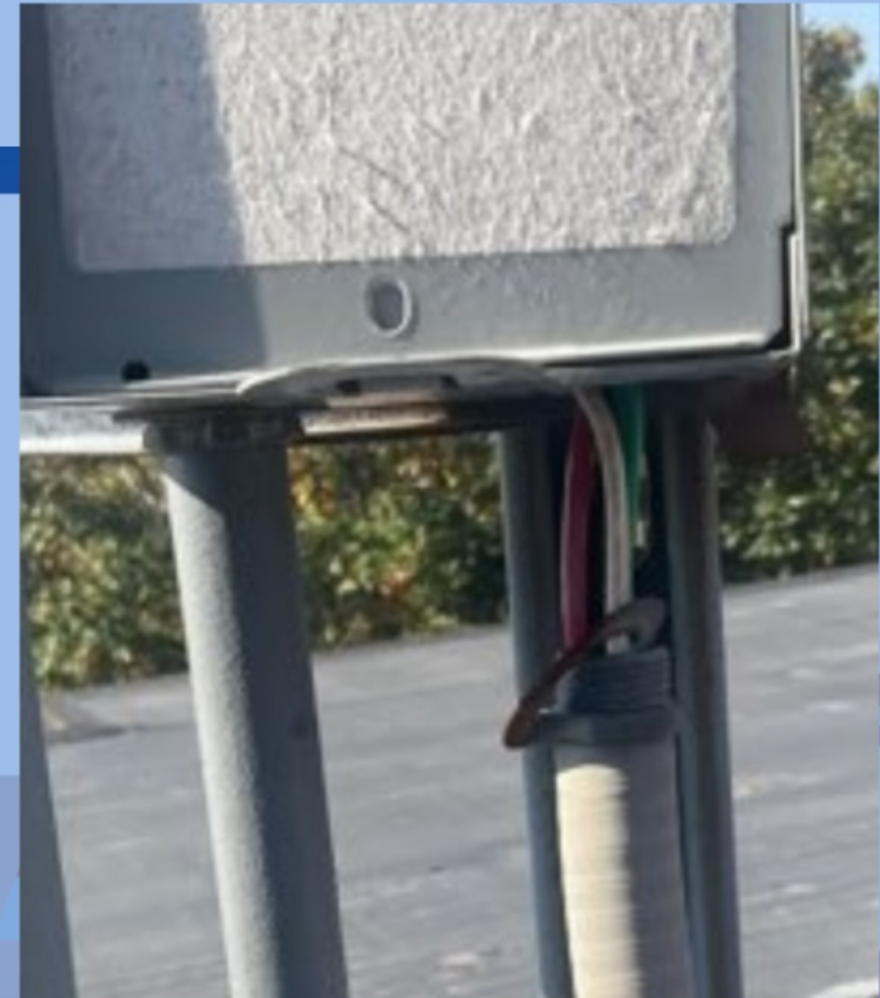
## HVAC Service Disconnects

Service disconnect panels and their associated flexible conduit connections are often found to be loose.

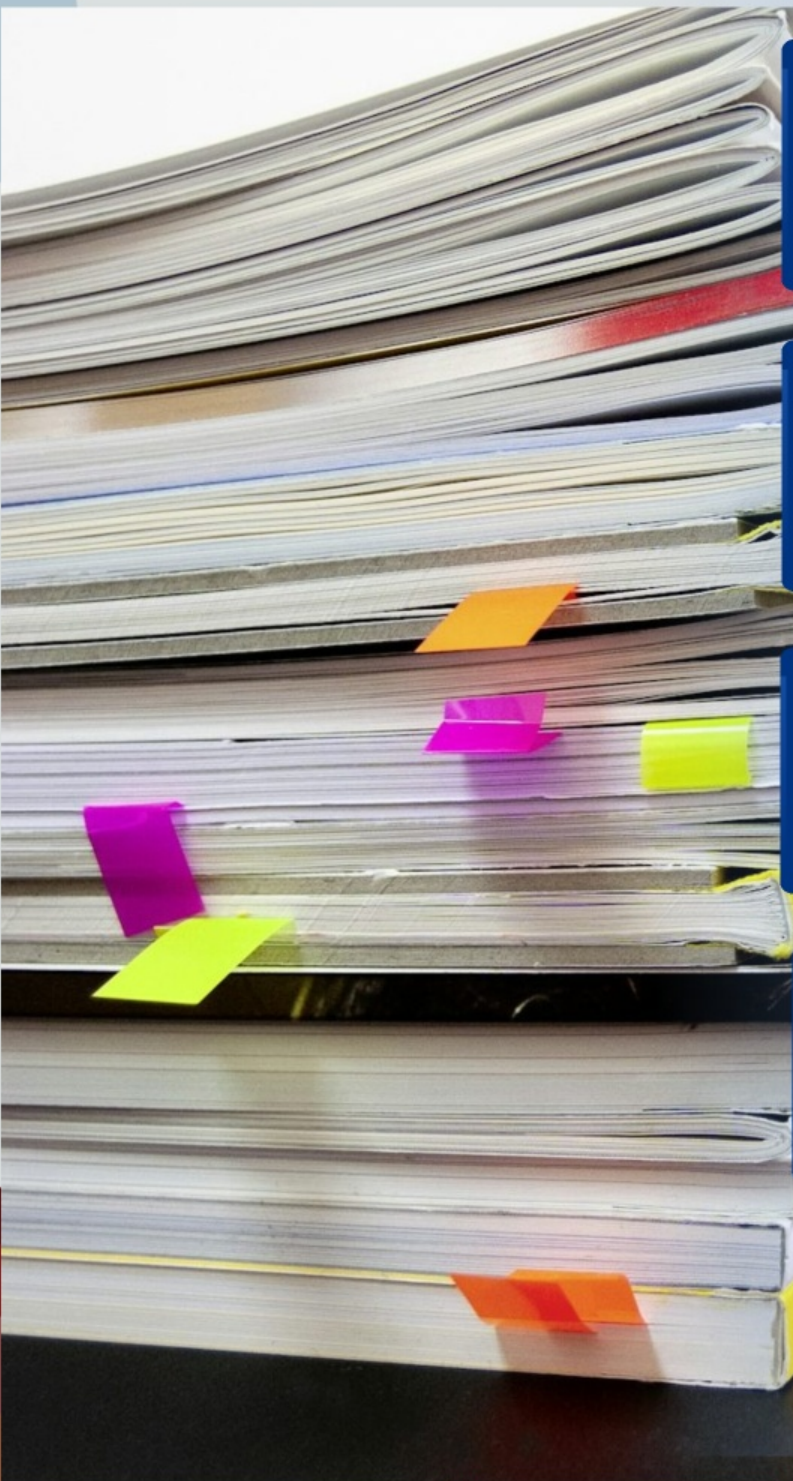
- Service Tags missing, expired, or illegible
- Fire extinguisher gauge reading under or overcharged

- Tag requires detailed visual verification
- Often only identified when undercharged
- Common in common areas, and exterior

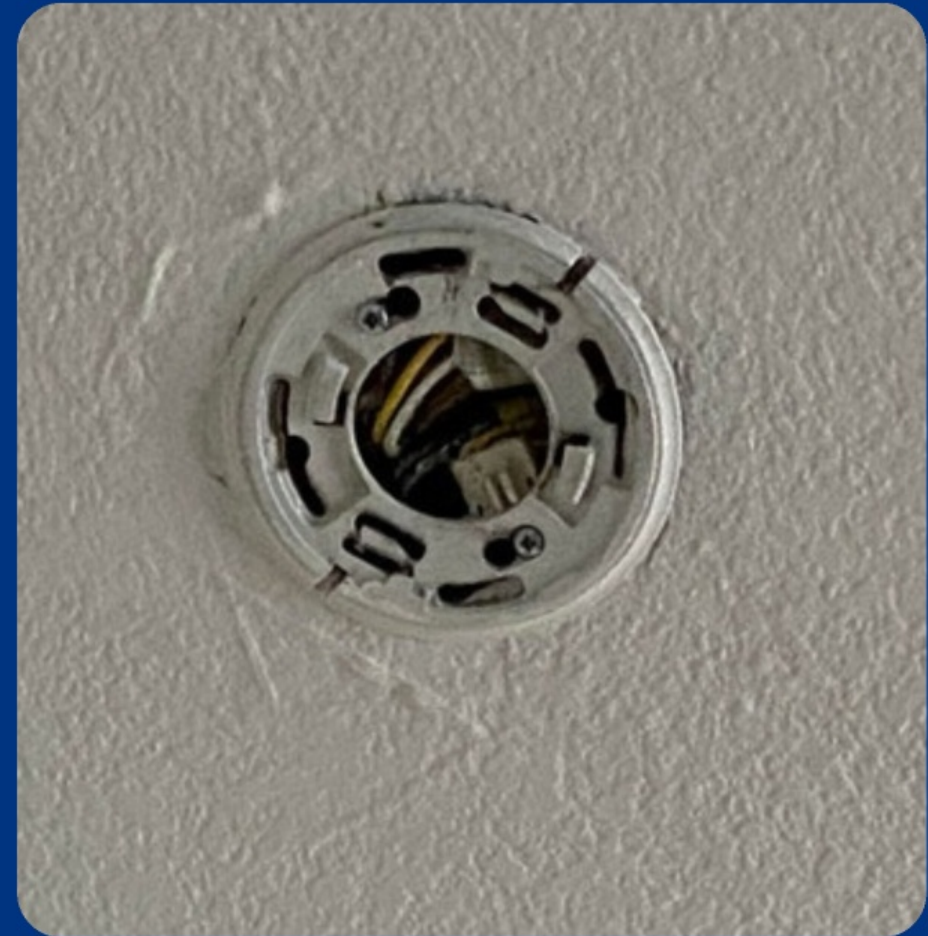
# Smoke Alarm- Missing or Inoperable

- Applies to every unit
- Requires ongoing maintenance, not one-time compliance
- Easily fails during point-in-time inspection

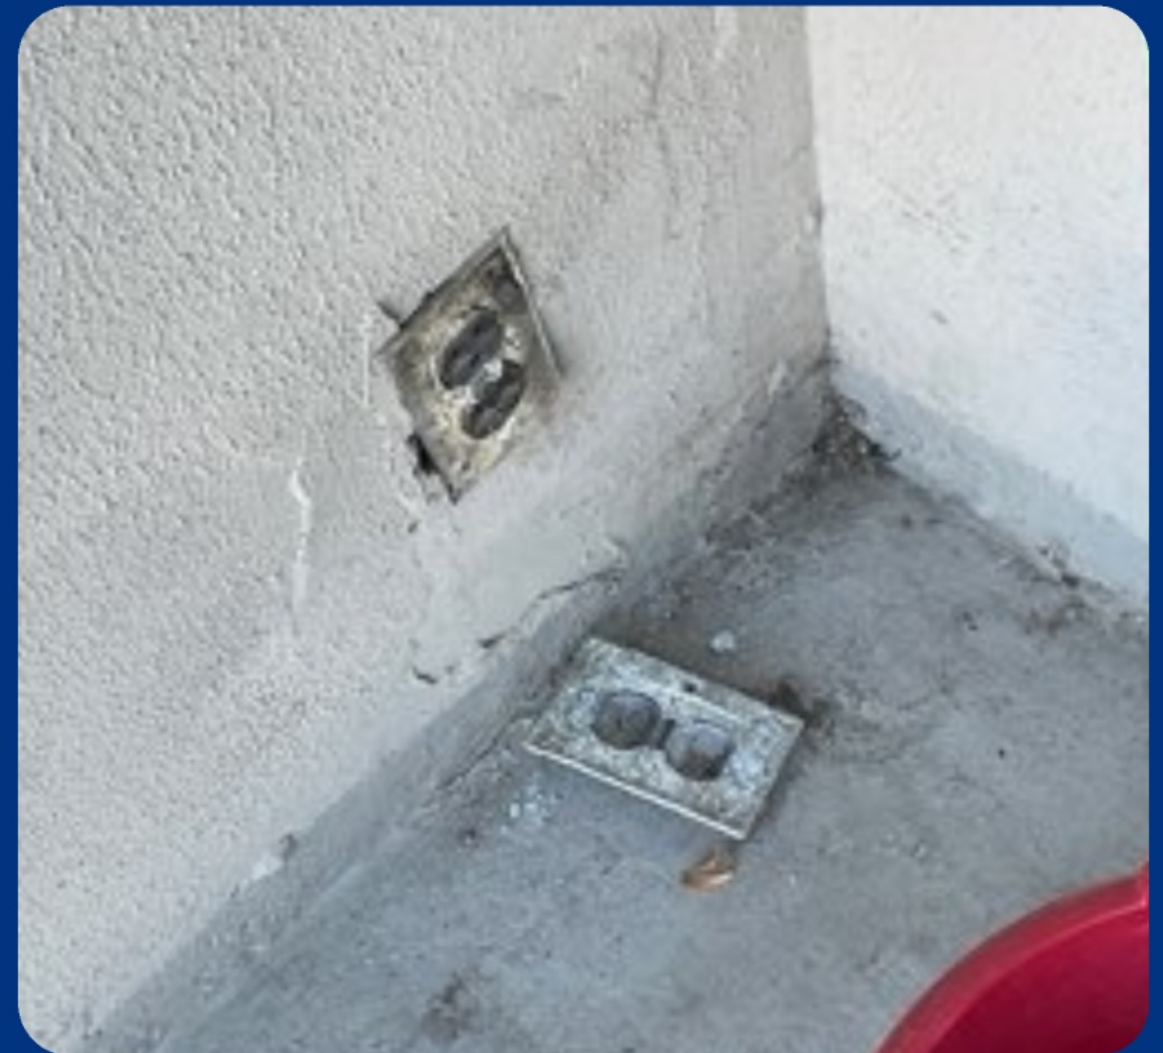
# Electrical- Exposed Conductor

- High-touch item (wear and tear from residents)
- Frequently overlooked during turns and maintenance
- Immediately visible to inspectors-no testing needed

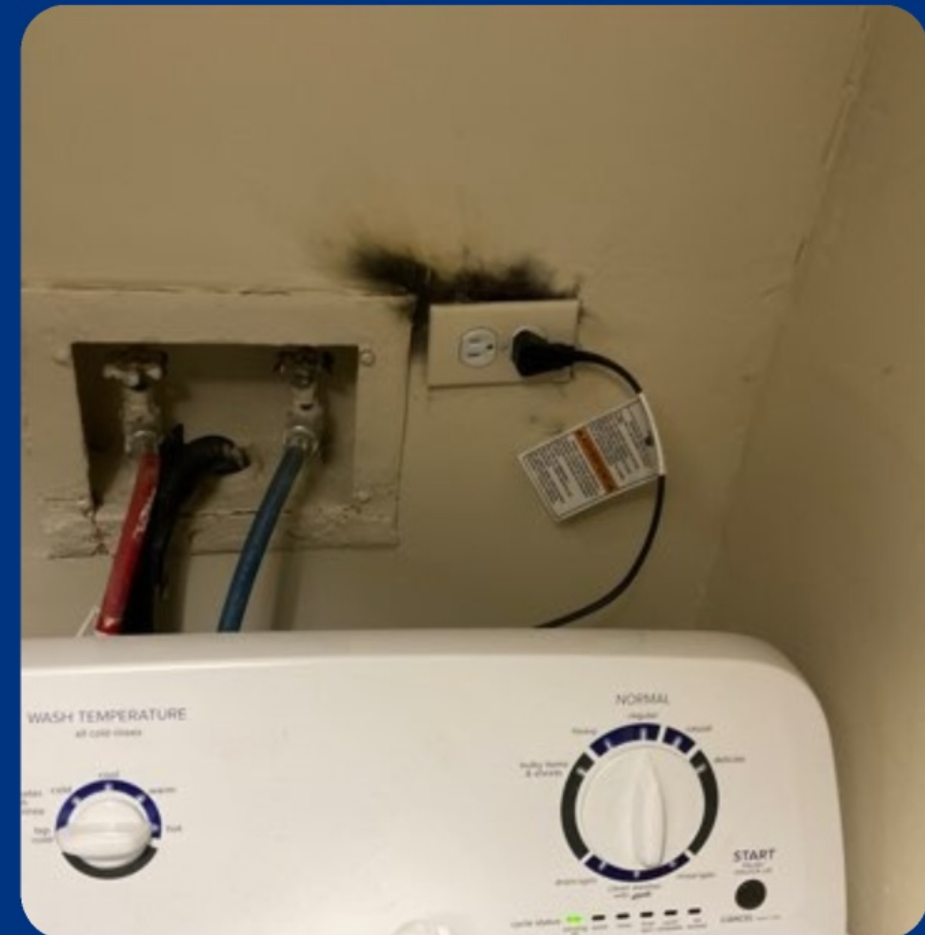
# GFCI Outlet-

- Requires active testing, not just visual inspection
- Often assumed to be working because it "has the button"
- Common in kitchens, baths, and exterior outlets

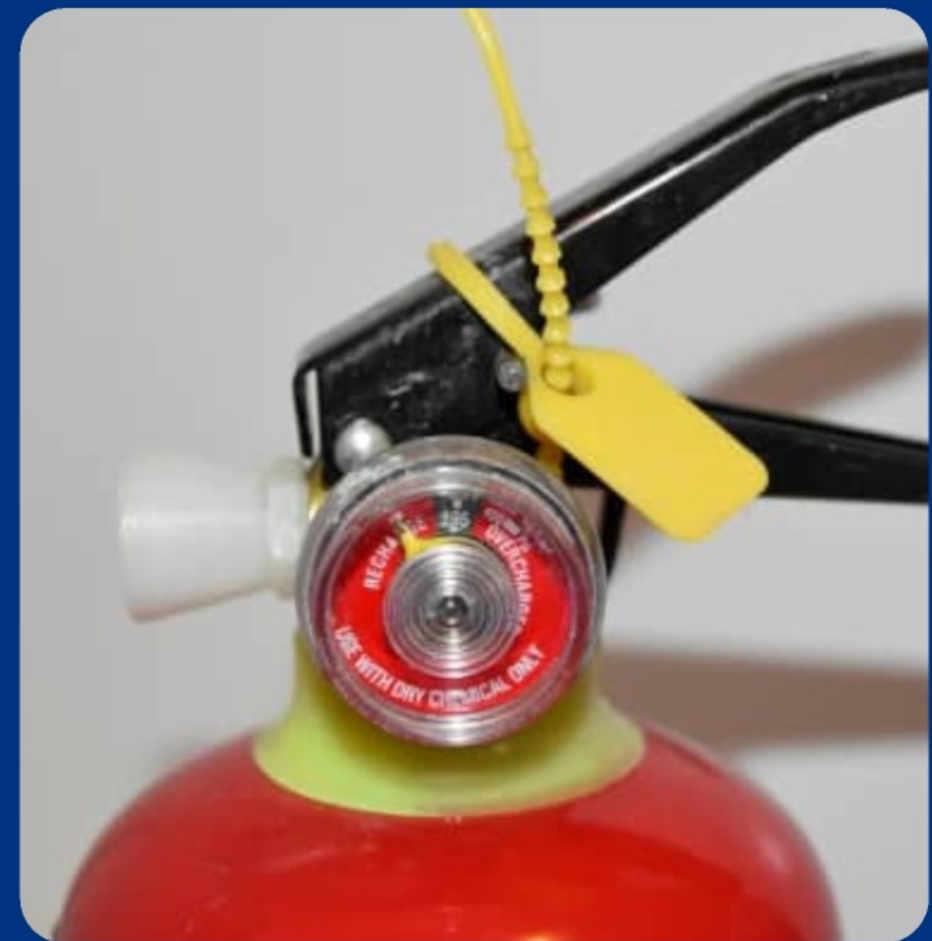
# Fire Extinguishers- Service Tags missing, expired or illegible

- Tag requires detailed visual verification
- Often only identified when undercharged
- Common in common areas, and exterior

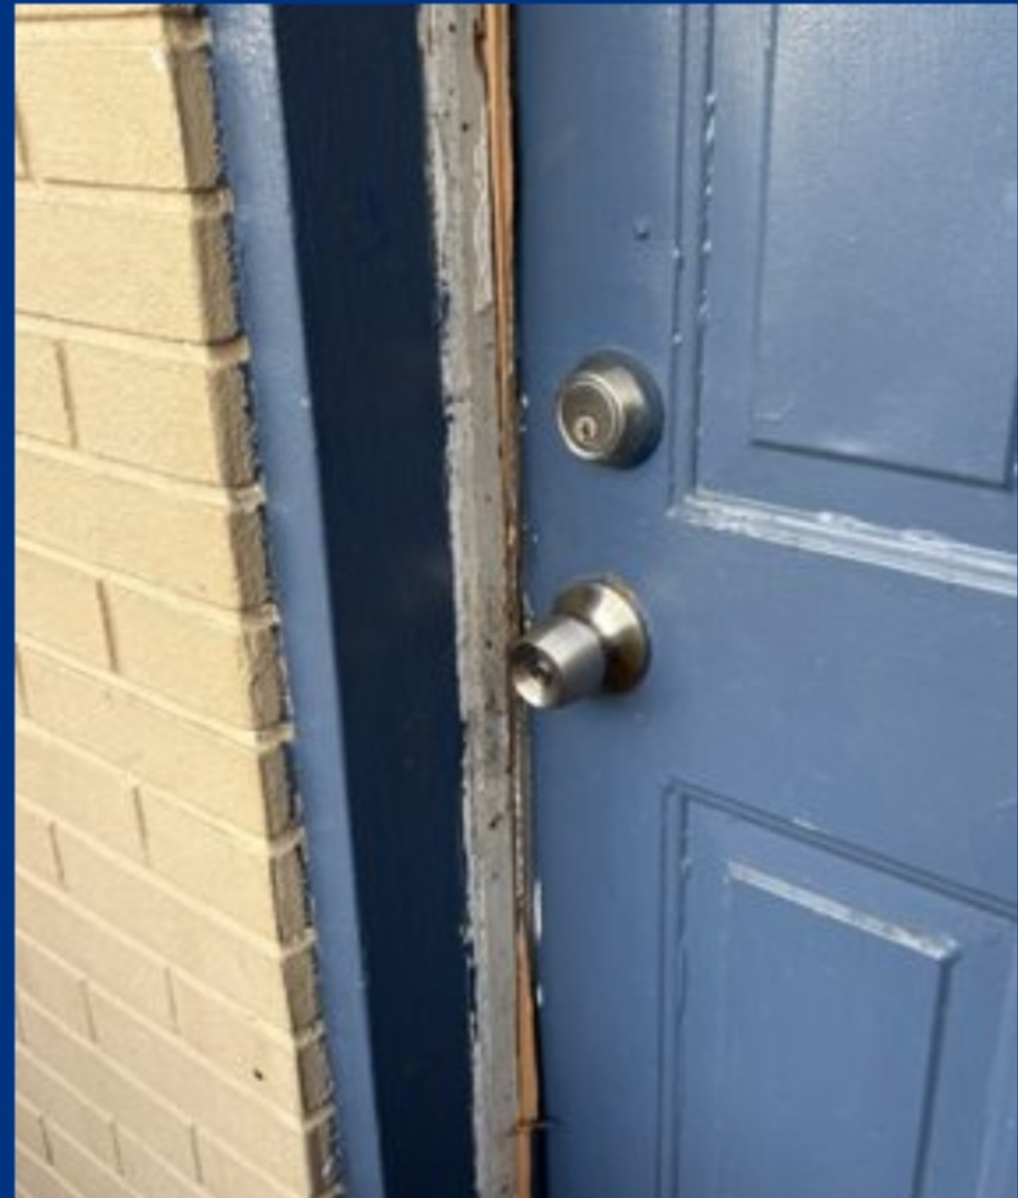
- Doors failing to latch as designed
- Doors missing hardware

- Requires active testing, not just visual inspection
- Active Fire Doors often not tested
- Common with self-closing devices
